Geobarrier System for Protection Against Rainfall-induced Slope Failure

KEYWORDS: Geobarrier system, Field instrumentation, Recycled concrete, Recycled asphalt.

Reference: Rahardjo, H., Satvanaga, A., Gofar, N., Leong, E.C., Kew, J.H., Wang, C.L. and Wong, J.L.H. (2019). Geobarrier System for Protection Against Rainfall-induced Slope Failure. *International Journal of Geoengineering Case Histories*, Vol.5, Issue 1, p. 26 - 42. doi: 10.4417/IJGCH-05-01-03

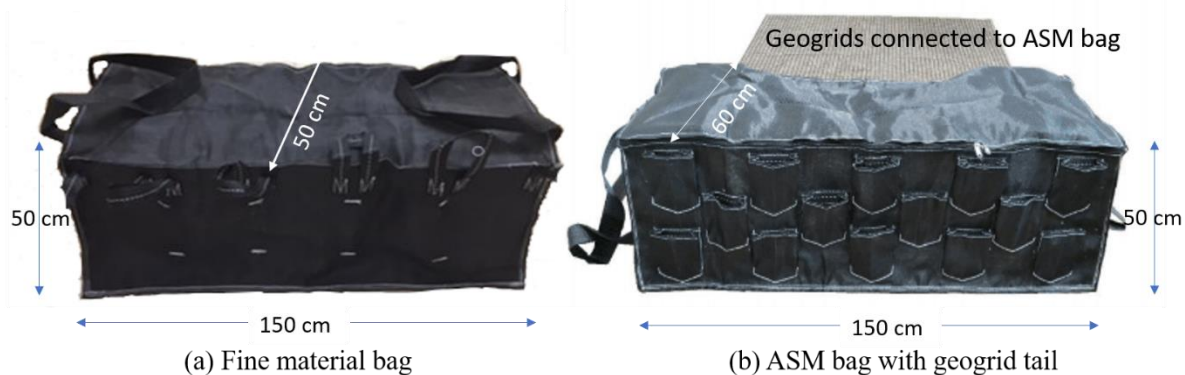
Figure 2 shows the geobags used for fine-grained material and ASM. The dimension of ASM geobag is 0.6 m width \times 0.5 m height \times 1.5 m length while the dimension of the geobag for the fine-grained material is 0.5 m width \times 0.5 m height \times 1.5 m length. The ASM bag is supported by specially designed pockets for planting different types of plants. The ASM bag is also connected to geogrids used as a reinforcing element. The bi-axial geogrids should be made from high-quality polyester yarn fibres with high tensile strength with a design life of 120 years and a tensile strength of 12 kN/m @ 2% strain and 30 kN/m @ 5% strain.

Figure 2. Geotextile bags for fine material and ASM.

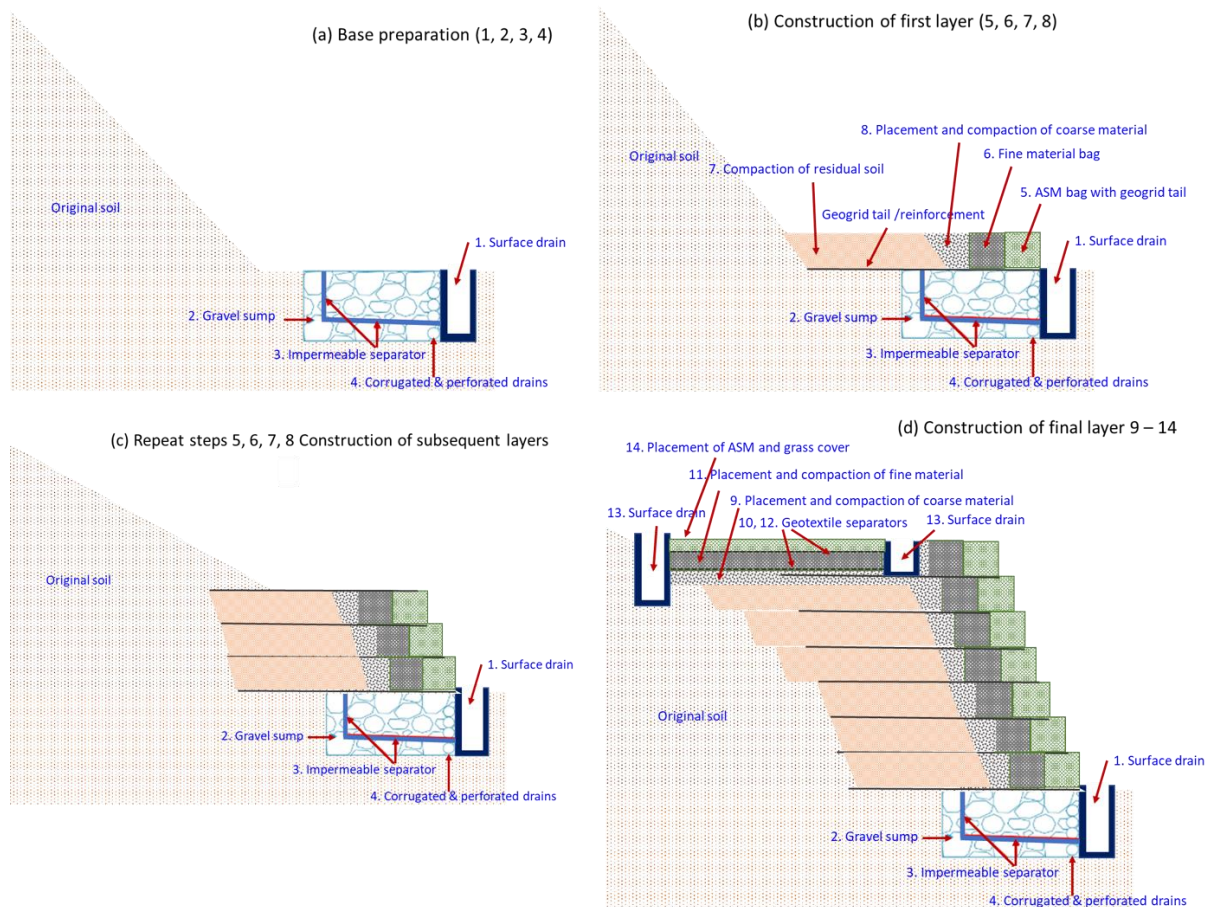
Construction of GBS was started with the excavation of the original slope to the required dimensions and depth of the GBS slope. A compacted gravel layer was placed at 1 m depth from the ground surface below the toe of the slope. The gravel layer was required near the slope toe in order to drain out the water from the GBS system into the main drain. During a rainfall event, some amount of water was expected to infiltrate into the ASM, the fine-grained and the coarse-grained layers before being discharged into the gravel sump at the base of the slope. Three corrugated perforated pipes were prepared to drain out water to the gravel sump, one from the coarse-grained layer, two from the fine-grained layer and one from the ASM layer. All pipes were wrapped with geotextile to avoid migration of soil particles that may block the pipe holes. The water from gravel sump was directed to the surface drain and then was channelled to the main drain. These stages are illustrated in Figure 3a.

The fine-grained material and the ASM were placed carefully into the geobags prior to the placement at the designated locations. The fine-grained material was compacted at a relative density between 70% and 90%. The placement of geobags was carried out in stages of 500 mm height. Each stage was started with the placement of the ASM geobag. The geogrid attached to ASM geobag was stretched up to its maximum length. Then, the geobag containing the fine-grained material was placed behind the ASM geobag. Residual soil was compacted to 90% compaction level to form a reinforced fill, leaving a 20 cm space between the compacted soil and the bag with the fine-grained material. Then, the coarse-grained material was placed and compacted to the required dry density. These steps are illustrated in Figure 3b and are repeated until the layer before the final level was reached (Figure 3c).

Figure 3. Construction stages of GBS.

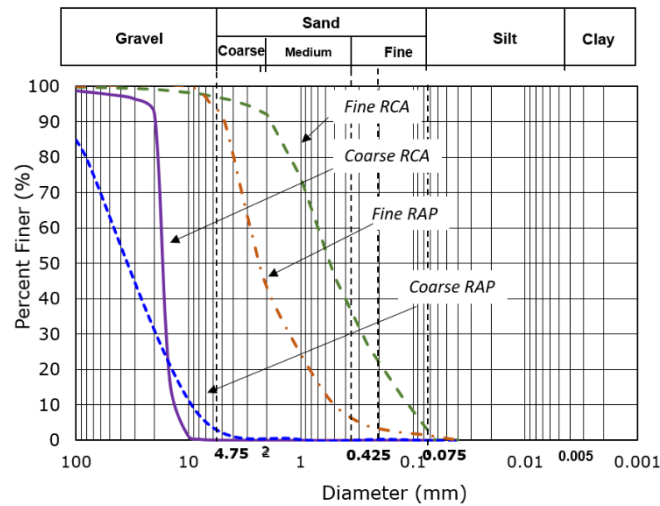
Figure 6. Grain size distribution of fine RCA, coarse RCA, fine RAP and coarse RAP.

The required properties derived from Figure 6 and 7 for the evaluation of capillary barrier effect are summarized in Table 2. Evaluation of the properties shows that the d_{50} ratios of the coarse and fine materials of GBS1, GBS2, and GBS3 were 13, 14 and 70, respectively which were greater than 5. The ψ_w -ratio of the fine- and coarse-grained materials of GBS1, GBS2, and GBS3 were 150, 32.5 and 188, respectively, which were greater than 10. The water-entry value (ψ_w) of coarse RCA and RAP were 0.1 and 0.08 kPa which were less than 1 kPa. The coefficient of saturated permeability of fine RAP was 4×10^{-4} m/s, which was greater than 10^{-5} m/s; however, the coefficient of saturated permeability of fine RCA was 1×10^{-6} m/s, less than 10^{-5} m/s. The evaluation showed that the combinations of the fine- and coarse-grained materials used in GBS1, GBS2, and GBS3 fulfilled all the criteria except for the coefficient of saturated permeability of fine RCA. Thus, in general the combinations of fine- and coarse-grained materials used in GBSs at Orchard Boulevard were effective as capillary barrier.

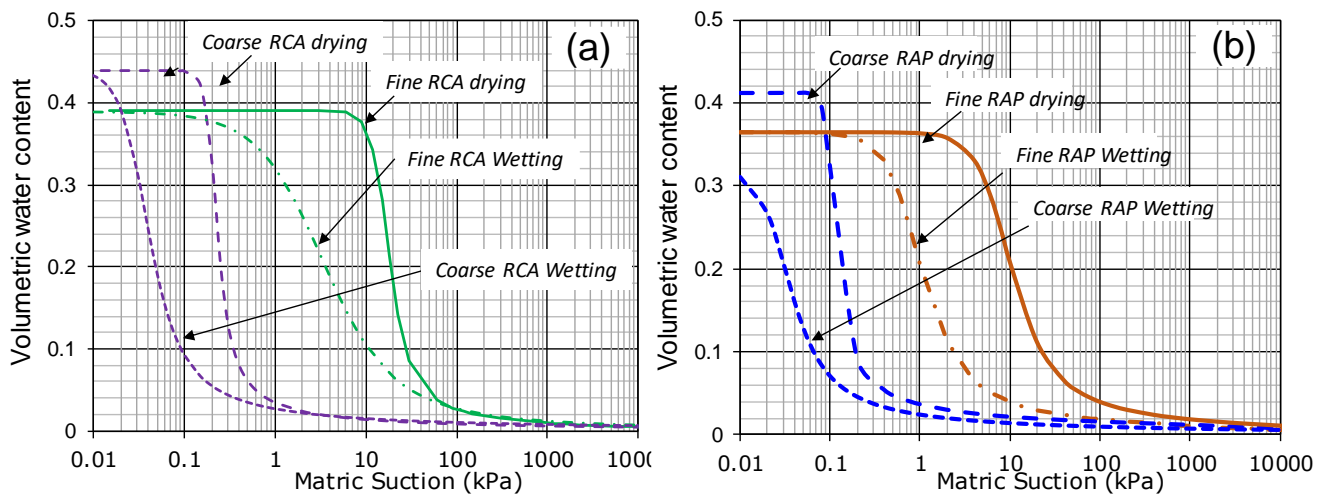
The configuration of the capillary barrier was evaluated based on several criteria. Smersud and Selker (2001) proposed that for an effective capillary barrier, the ratio of particle size (defined as d_{50}) of the coarse- and fine-grained materials should be greater than 5. Furthermore, Rahardjo et al. (2007) suggested some criteria based on: i) the water-entry value, ψ_w , of the coarse-grained soil (preferably <1 kPa); ii) the ratio between the water-entry value of the fine-grained material and the coarse-grained material (ψ_w -ratio) to be greater than 10, iii) the saturated coefficient of permeability of the fine-grained non-cohesive material (preferably $>10^{-5}$ m/s). The grain size distributions of coarse RCA and fine RCA as well as coarse RAP and fine RAP are shown in Figure 6 while the drying and wetting SWCCs of the materials are presented in Figure 7.

Figure 7. SWCCs of (a) fine RCA and coarse RCA and (b) fine RAP and coarse RAP.

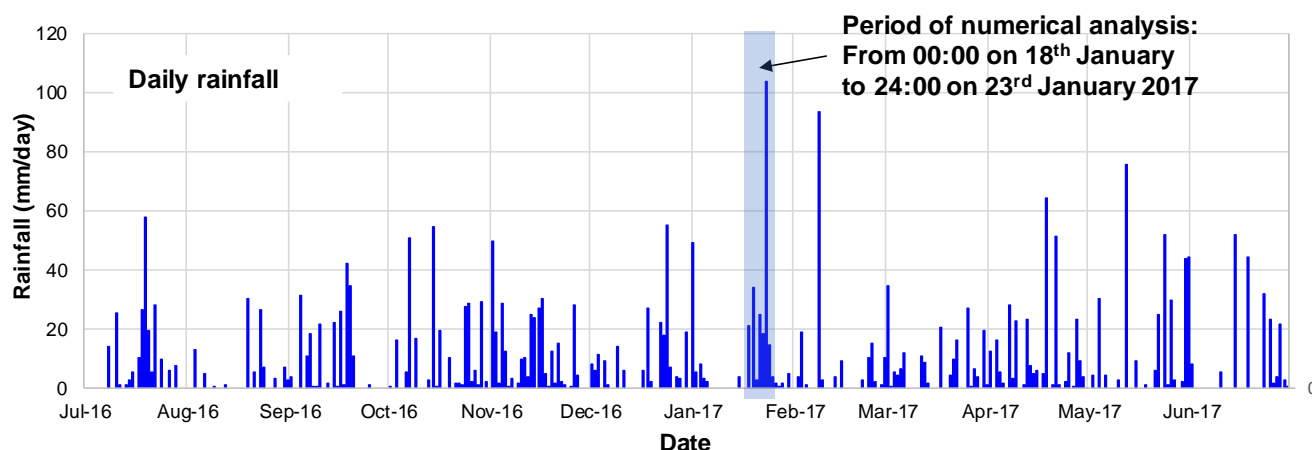
The performance of the GBSs at Orchard Boulevard was monitored for one year i.e. from 1st July 2016 to 30th June 2017. Figure 8 shows daily rainfall during the monitoring period. Rainfall monitoring at the study site indicated that the monthly rainfalls were quite different from the typical trend in Singapore. The cumulative yearly rainfall was 2819 mm which was higher than the average annual rainfall in Singapore based on the long term record from NEA Singapore (1981–2010) i.e. 2166 mm (National Environmental Agency, 2018). The number of rainfall days during the monitoring period was 178 days, which was higher than the average annual number of rainfall days in Singapore (167 days) (National Environmental Agency, 2018). The maximum daily rainfall occurred during the monsoon period in January 2017 i.e. 103.8 mm. The month of January 2017 started with a dry period for about two weeks and ended with a very wet period towards the end of the month. Therefore, rainfalls in the second half of January 2017 were selected for numerical analysis of the response of GBSs to rainfall infiltration.

Figure 8. Daily rainfall during the monitoring period (1st July 2016 – 30th June 2017).

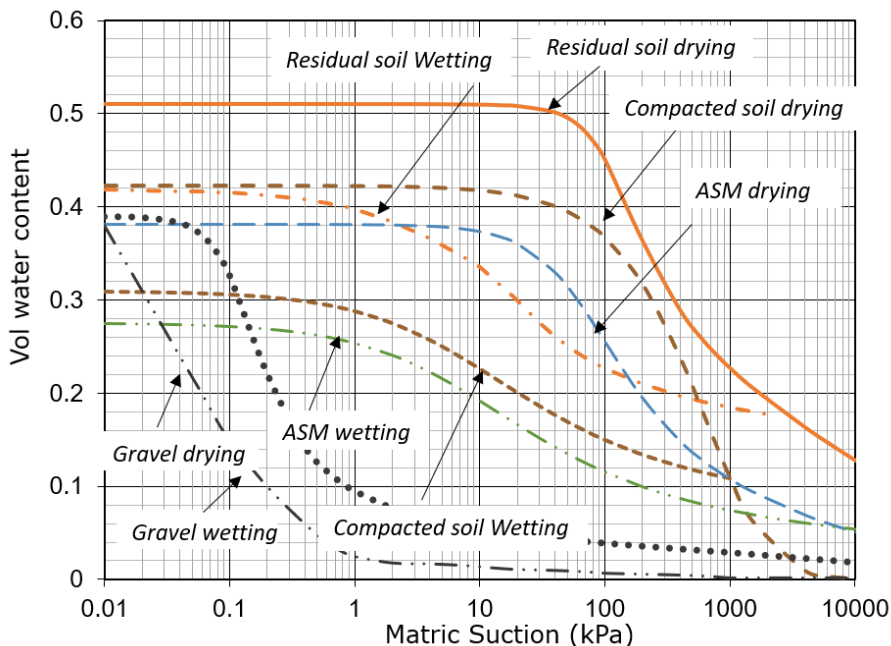
The drying and wetting SWCCs of the residual and compacted residual soils as well as the ASM and gravel are shown in Figure 13 while the drying and wetting SWCCs of the fine and coarse RCA as well as the fine and coarse RAP are shown in Figure 7. Wetting SWCCs were used in the numerical analysis to replicate the wetting process due to the extreme rainfall. In addition, Bashier et al. (2016) indicated that the use of wetting SWCC and permeability function is associated with worst scenario since the numerical analysis results predicted a higher infiltration rate. Hence, the factor of safety is the lowest if the numerical analysis incorporates wetting SWCC and permeability function. The wetting permeability function was determined from the SWCC wetting curves of all materials using a statistical method (Child and Collis-George, 1950) are shown in Figure 14.

Figure 13. SWCC of Residual and compacted residual soil, and ASM and Gravel.

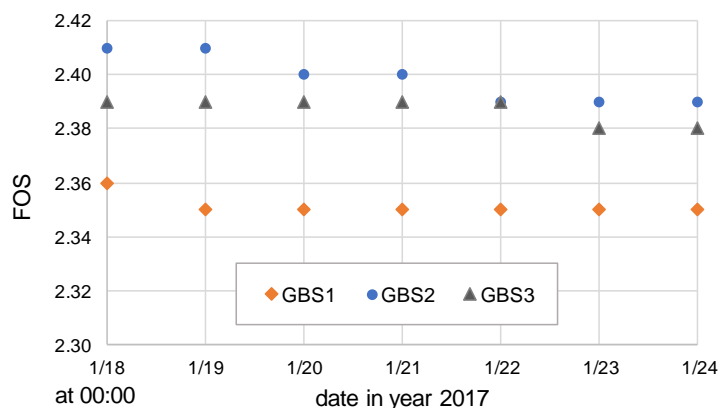
Figure 16 shows the critical slip surface obtained from stability analyses of the slope with GBS at the end of rainfall. Since the PWP was generally constant, the factor of safety was almost constant with time. The transient FOS for all GBS is shown in Figure 17.

Figure 17. Transient Factor of safety predicted by slope stability analysis.
