# Erosion and Sedimentation Analysis of Rural Channels (RC) and Main Drainage Channels (MDC) on Tidal Lowland in Indonesia

**Abstract**— The purpose of this study is to conducting a field study by surveying and investigating the Rural Channel (RC) and Main Drainage Channel (MDC) and to analyzing the grainsize diameter in the P8-13S scheme, an accumulation of sediment transport in the channel is found, namely erosion occurring in the Rural Channel (RC) and in Drainage Channel (MDC).

The location of research is reclaimed tidal delta region Telang I representing land typology A/B and the survey was conducted at 13 South Secondary Primary 8 scheme on tertiary channels.

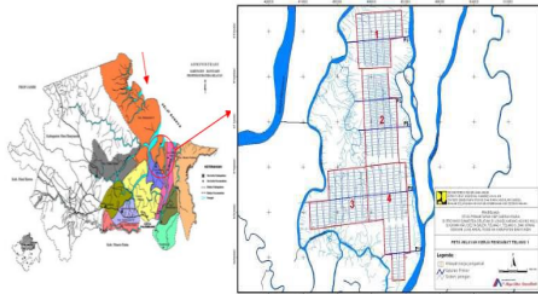
Fig. 1. Research location

The next design for an open channel system is prepared by the Institute of Technology Bandung (ITB). The system consists of a main line (also used for navigation), secondary channels and tertiary channels. Figure 1. Map of the research location.

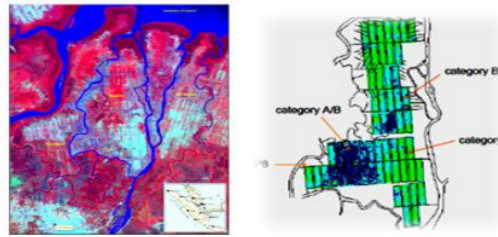
Fig. 2. And Fig. 3. Geographic location and Hydro-topographic conditions of delta Telang I

Figure 3 shows the layout of the hydro-topographic conditions in the area Telang I. Hydrology of the block is determined by adjacent channel conditions, the status of water in each channel, the operation of the door, the influence of the tides, and the climatic conditions such as rainfall and evapo-transpiration [7].

Geographically, the region Telang I is located at  $02^{\circ} 29'$  to  $02^{\circ} 48'$  latitude and  $104^{\circ} 30'$  until  $104^{\circ} 52'$  East Longitude. Generally, Telang I is located in the north bordering the Strait of Bangka, south bordering the river by contrast, the east with the Musi river and the west bordering the Telang I river (Figure 2).

Hydrologically, Telang I area is an area surrounded by tidal rivers. Region east with the Musi river, the west bordering the Telang river, Bangka Strait in the south and the north is bordered by the river by contrast.

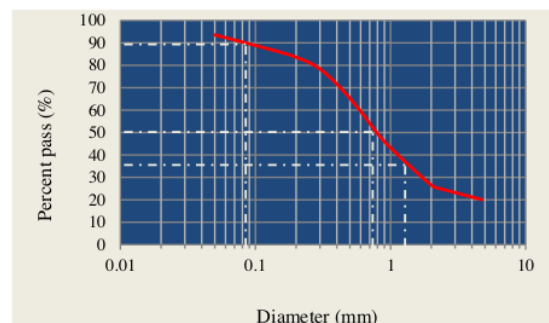
Fig. 4. Grain size distribution chart of Rural Channel

From Figure 4 is obtained  $d_{35}$ ,  $d_{50}$  and  $d_{90}$  granular diameters, with the respective values of  $d_{35}$  (granules with percent pass filter up to 35% are 1.50 mm);  $d_{50}$  (granules with percent pass filter up to 50% are 0.80 mm) and  $d_{90}$  (granules with percent pass filter up to 90% are 0.08 mm). The size of the granules with a certain diameter is needed to classify whether the granules in the Rural Channel (RC) and Main Drainage Channel (MDC) include cohesive or non-cohesive sediment grains such as the discussion of cohesiveness of sediment material [8].

From Table 2 is obtained cumulative passing percent (% pass) from the analysis of the sediment grain size in the channel by dividing the sieve size that are small, medium or large. The results of the analysis show that filter No. 4 produces a percentage of passing 41.43% and filter No. 100 has a percentage of passing 6.35%. To get the grain diameter measurement results of the sieve analysis, it is illustrated in the log graph of the distribution of grain diameters for each channel both in the Rural Channel (RC) and in the Main Drainage Channel (MDC). The graph of the depiction of the grain size distribution is given in Figure 4.

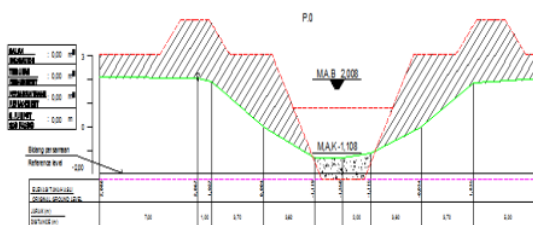
Fig. 5. Cross profile of Rural Channel (RC) on section  $P_0$

Based on Figure 5, Figure 6 and Figure 7, the erosion that occurred in the Rural Channel (RC) at the cross section of the  $P_0$  cross section at the point + 0.00 (at the beginning of the channel) amounted to  $46,814 \text{ m}^3$ . At section  $P_{38}$  (cross section at the centre of the channel) at a distance of 1,500 m from the beginning of the channel, erosion occurred at  $26,360 \text{ m}^3$  and at section  $P_{76}$  (cross section at the end of the channel) at a distance of 3,800 m from the channel starting point, an erosion

Sedimentation that occurred in the Rural Channel (RC) on the cross section  $P_0$  cross section at the point of 0.00 (at the beginning of the channel) was  $6,150 \text{ m}^3$ . At section  $P_{38}$  (cross section at the centre of the channel) at a distance of 1,500 m from the beginning of the channel, sedimentation occurred at  $7565 \text{ m}^3$  and at section  $P_{76}$  (cross section at the end of the channel) at a distance of 3,800 m from the channel starting point, sedimentation occurred at  $11,685 \text{ m}^3$ . Cumulatively, the average sedimentation that occurs in the SPD channel along the 3,800 m is  $8092 \text{ m}^3$ .

Rural Channel (RC) survey and measurements were carried out to obtain longitudinal and transverse profiles. For cross sections of the Main Drainage Channel (MDC) as shown in Figure 5, Figure 6 and Figure 7.

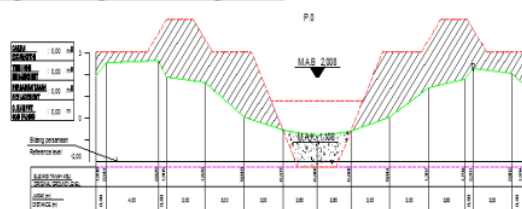
Fig. 8. Transverse profile of Main Drainage Channel (MDC) on section  $P_0$

From the Figure 8, Figure 9 and Figure 10, the magnitude of erosion that occurred in the Main Drainage Channel (MDC) at the cross section of  $P_0$  crossed at + 0.00 (at the beginning of the channel) was  $4,857,000 \text{ m}^3$ . In section  $P_{36}$  (cross section at the centre of the channel) at a distance of 1,500 m from the start of the channel, erosion occurred at  $3,175,000 \text{ m}^3$  and at section  $P_{76}$  (cross section at the end of the channel) ie at a distance of 3,800 m from the channel starting point, erosion occurred amounting to  $2,946,000 \text{ m}^3$ . Cumulatively, the

Sedimentation that occurred in the Main Drainage Channel (MDC) at the cross section  $P_0$  at the point +0.00 (at the beginning of the channel) was  $574,000 \text{ m}^3$ . At section  $P_{38}$  (cross section in the middle of the channel) at a distance of 1,500 m from the beginning of the channel, sedimentation occurred at  $792,000 \text{ m}^3$  and at section  $P_{76}$  (cross section at the end of the channel) at a distance of 3,800 m from the starting point of the channel, sedimentation occurred at  $1,137,000 \text{ m}^3$ . Cumulatively, the average sedimentation that occurred in the Rural Channel (RC) along the 3,800 m was  $898,467 \text{ m}^3$ .

The survey results and Main Drainage Channel (MDC) measurements in the P8-13S scheme show patterns of erosion and sedimentation. The results are drawn cross sections as in Figure 8, Figure 9 and Figure 10.

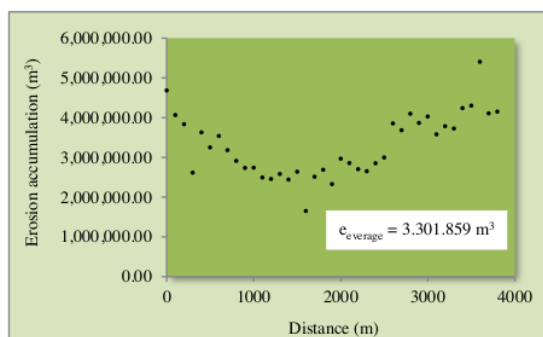
Figure 11. Erosion accumulation in the Rural Channel (RC)

The results of surveys and measurements carried out along the 3900 m, obtained erosion patterns forming a semi logarithmic curve as shown in Figure 11. the erosion pattern is obtained in the Main Drainage Channel (MDC) where at the starting point (downstream of the channel) forms a high erosion pattern then in the middle of the channel has a low pattern and towards the upstream the channel forms an enlarged pattern again. This can be interpreted that the erosion that occurs in the Rural Channel (RC) is caused because at the beginning of the channel occurs at accelerating flow and the more in the middle of the channel has a relatively constant velocity then there will be an accelerated flow to the end of the channel (upstream of the channel) and an average erosion value of  $3,301,859 \text{ m}^3$ .

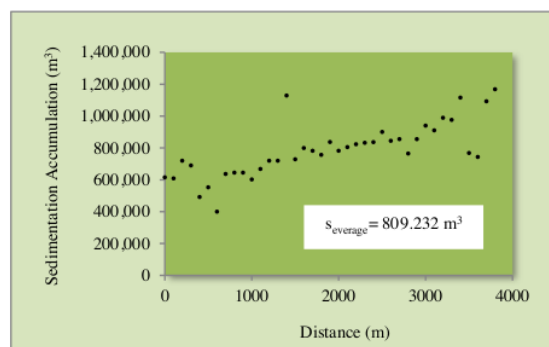
Fig. 12. Accumulation of sedimentation in the Rural Channel (RC)

Rural Channel (RC) sedimentation patterns as shown in Figure 12. Shows at the beginning of the channel a small sedimentation pattern then enlarges upstream to the end of the channel. This is because the Rural Channel (RC) secondary channel in P8-13S is broken at the end of the channel, meaning that the channel is not translucent at the end of the channel. At the beginning of the channel, less sediment enters and then a build up of suspended material occurs in one third of the channel and subsequently the sedimentation is constant. The sedimentation value in the Rural Channel (RC) is an average of  $809,232 \text{ m}^3$ .

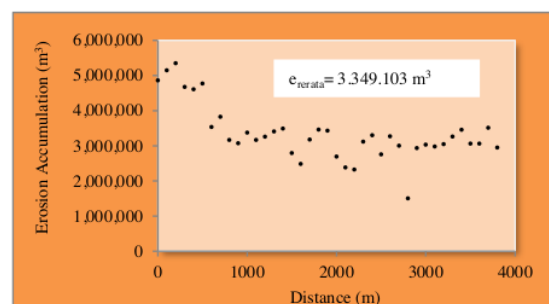
Fig. 13. Erosion Accumulation on Main Drainage Channel (MDC)

The survey results and Main Drainage Channel (MDC) measurements obtained erosion and sedimentation patterns as shown in Figure 13 below, where the erosion patterns in the Main Drainage Channel (MDC) have a small pattern at the beginning of the channel to the end of the channel along the 3,800 m. This erosion pattern is caused because when the water in the paddy field or from the tertiary canal is drained, there is accumulation of flow from the Main Drainage Channel (MDC) itself or from the tertiary channel. Whereas at the distance further upstream of the Main Drainage Channel (MDC), the flow from the tertiary plots has decreased, reducing the flow capacity so that the velocity also decreases with an average erosion of 3,349,103 m<sup>3</sup>.

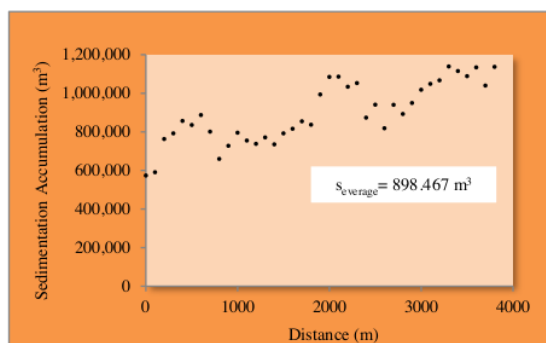
Fig. 14. Accumulation of sedimentation in the Main Drainage Channel (MDC)

For Main Drainage Channel (MDC) sedimentation values have the opposite trend of erosion patterns that occur as shown in Figure 14. Shows the pattern of sedimentation in the beginning (upstream channel) has a low pattern and increasingly upstream has increased sedimentation accumulation. This is possible because when the water in the tertiary plot is drained, the tertiary channel at the beginning of the Main Drainage Channel (MDC) has a small flow in the last channel and increasingly towards the beginning of the channel the flow capacity is quite large because there is still a flow in the tertiary plot that is drive the flow in the initial tertiary plot. The Sedimentation value in the Main Drainage Channel (MDC) is an average of 898,467 m<sup>3</sup>.
